SAFETY ALERT – SEPTEMBER 2009

Work Positioning Platform Tipping

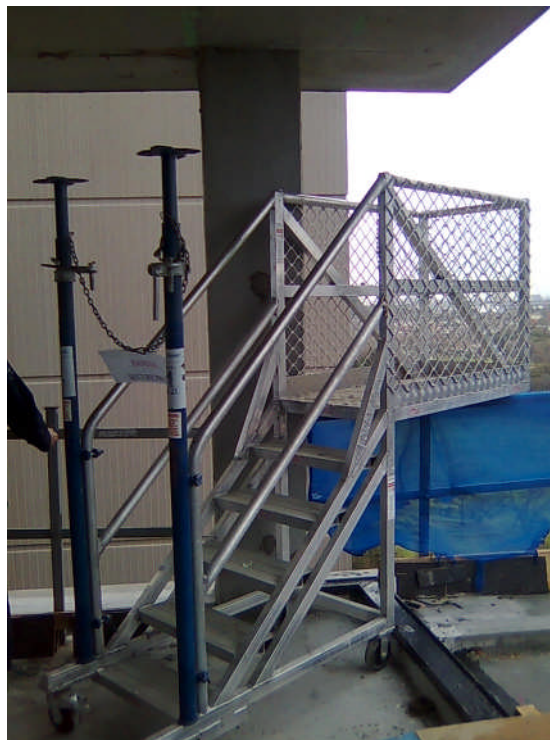
Descending from the platform, he retracted the adjustable props (see photo below) & was checking his work when he noticed he'd missed a spot.

The operative climbed back on the platform without re-fixing the props causing it to tip forward over the balcony handrail.

- Chain installed between props so at eye-level when retracted
- Sign attached to chain stating "Danger – Secure Props"
- Prop outers replaced with longer ones to accommodate additional thread –lock pin, ensuring prop inner plate is a maximum 100mm from soffit
